Investigation of Construction Failure of Harbour Cay Condominium in Cocoa Beach, Florida

September 1981

H. W. Lew
N. J. Carino
S. G. Fattal
M. E. Batts

The investigation of the collapse of a five-story reinforced concrete flat-plate structure under construction at Cocoa Beach, Florida is presented in this report. The investigation included onsite inspection, laboratory tests and analytical studies.

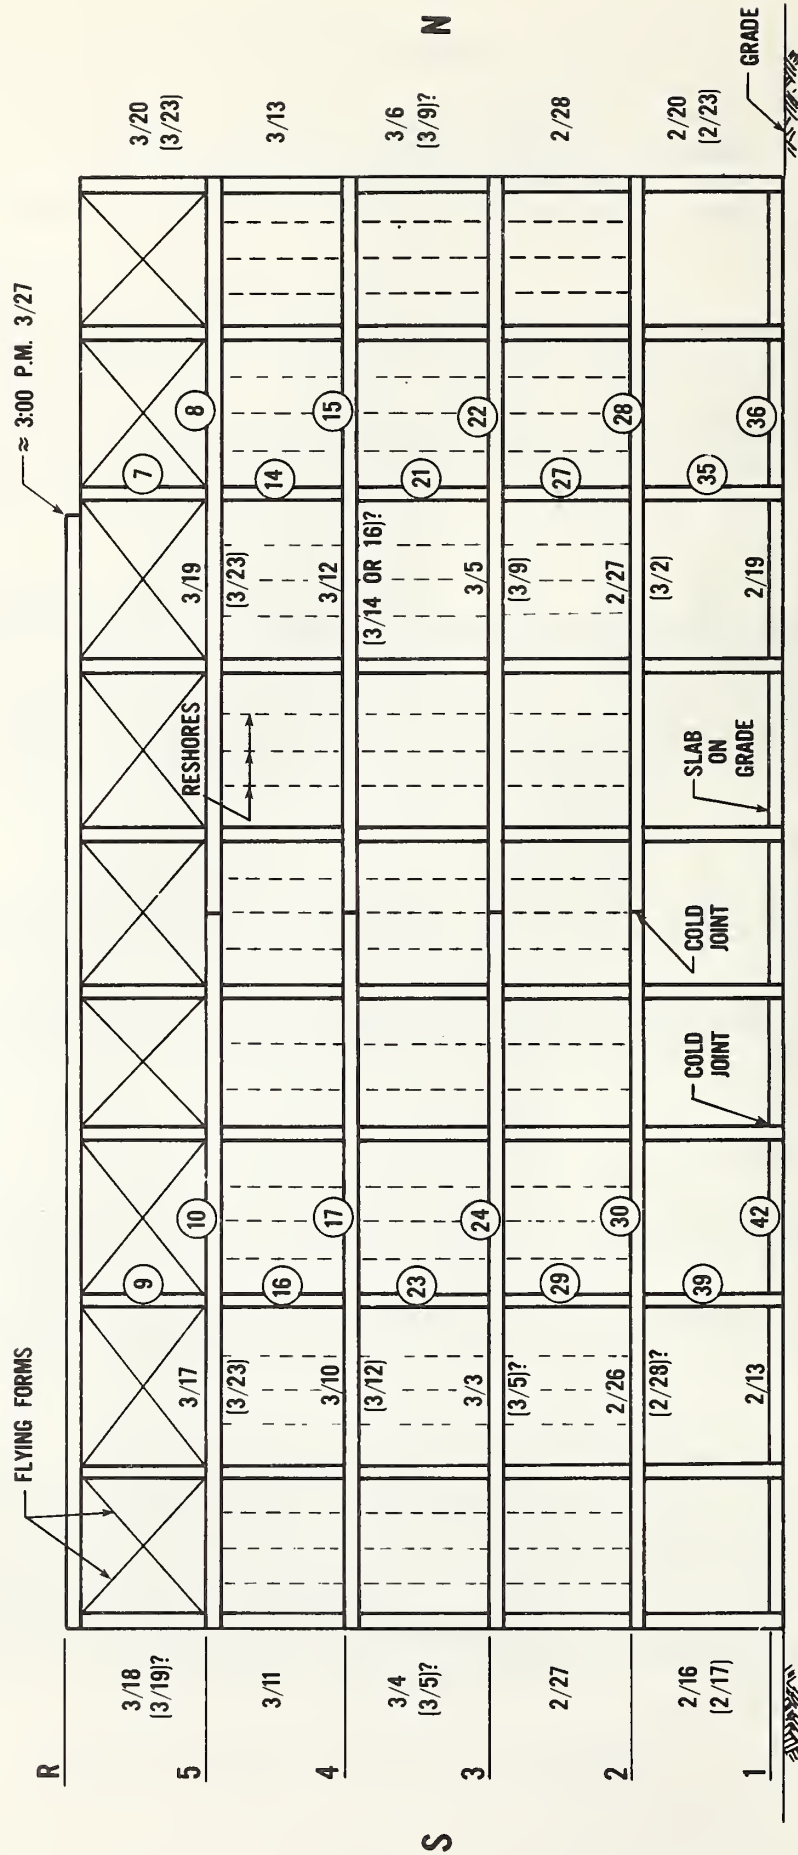
Figure 2.11 Assumed state of construction at time of the collapse

Because of the uncertainties noted above, for the purpose of analysis, all three stories below the fifth floor were assumed to be fully reshored, while no reshores were assumed within the first story (see fig. 2.11). The effect of this assumption would make the calculated stresses less critical than if partial reshoring were assumed in the second and third stories.

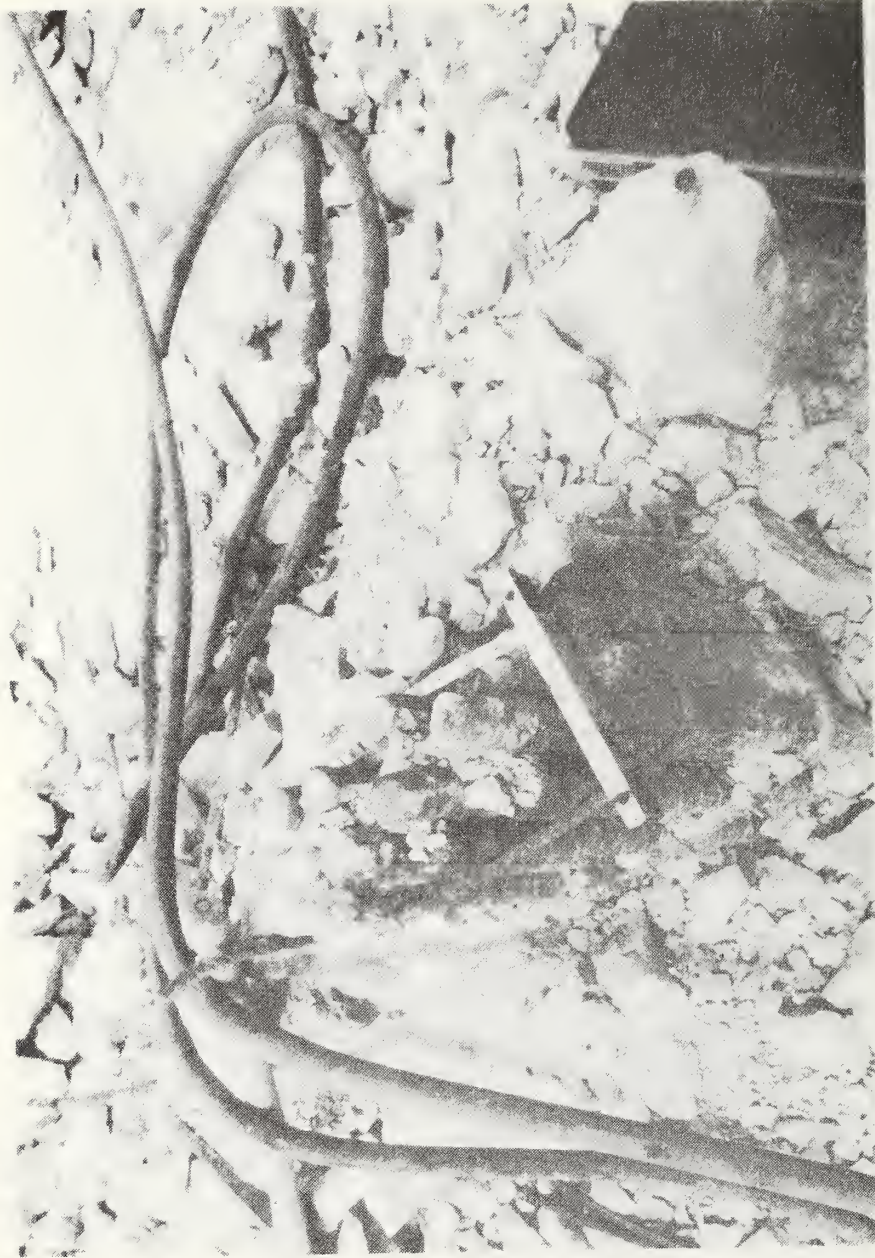
Figure 3.3 Congested reinforcement in a first-story column

It was also noted from the first-story column sections still standing on the ground level that where 8- # 10 or 8- # 11 bars were lapped, in a 10 x 18 in (250 x 460 cm) column section, the total steel area exceeded considerably the maximum limit of four percent of the gross area of the concrete allowed by the

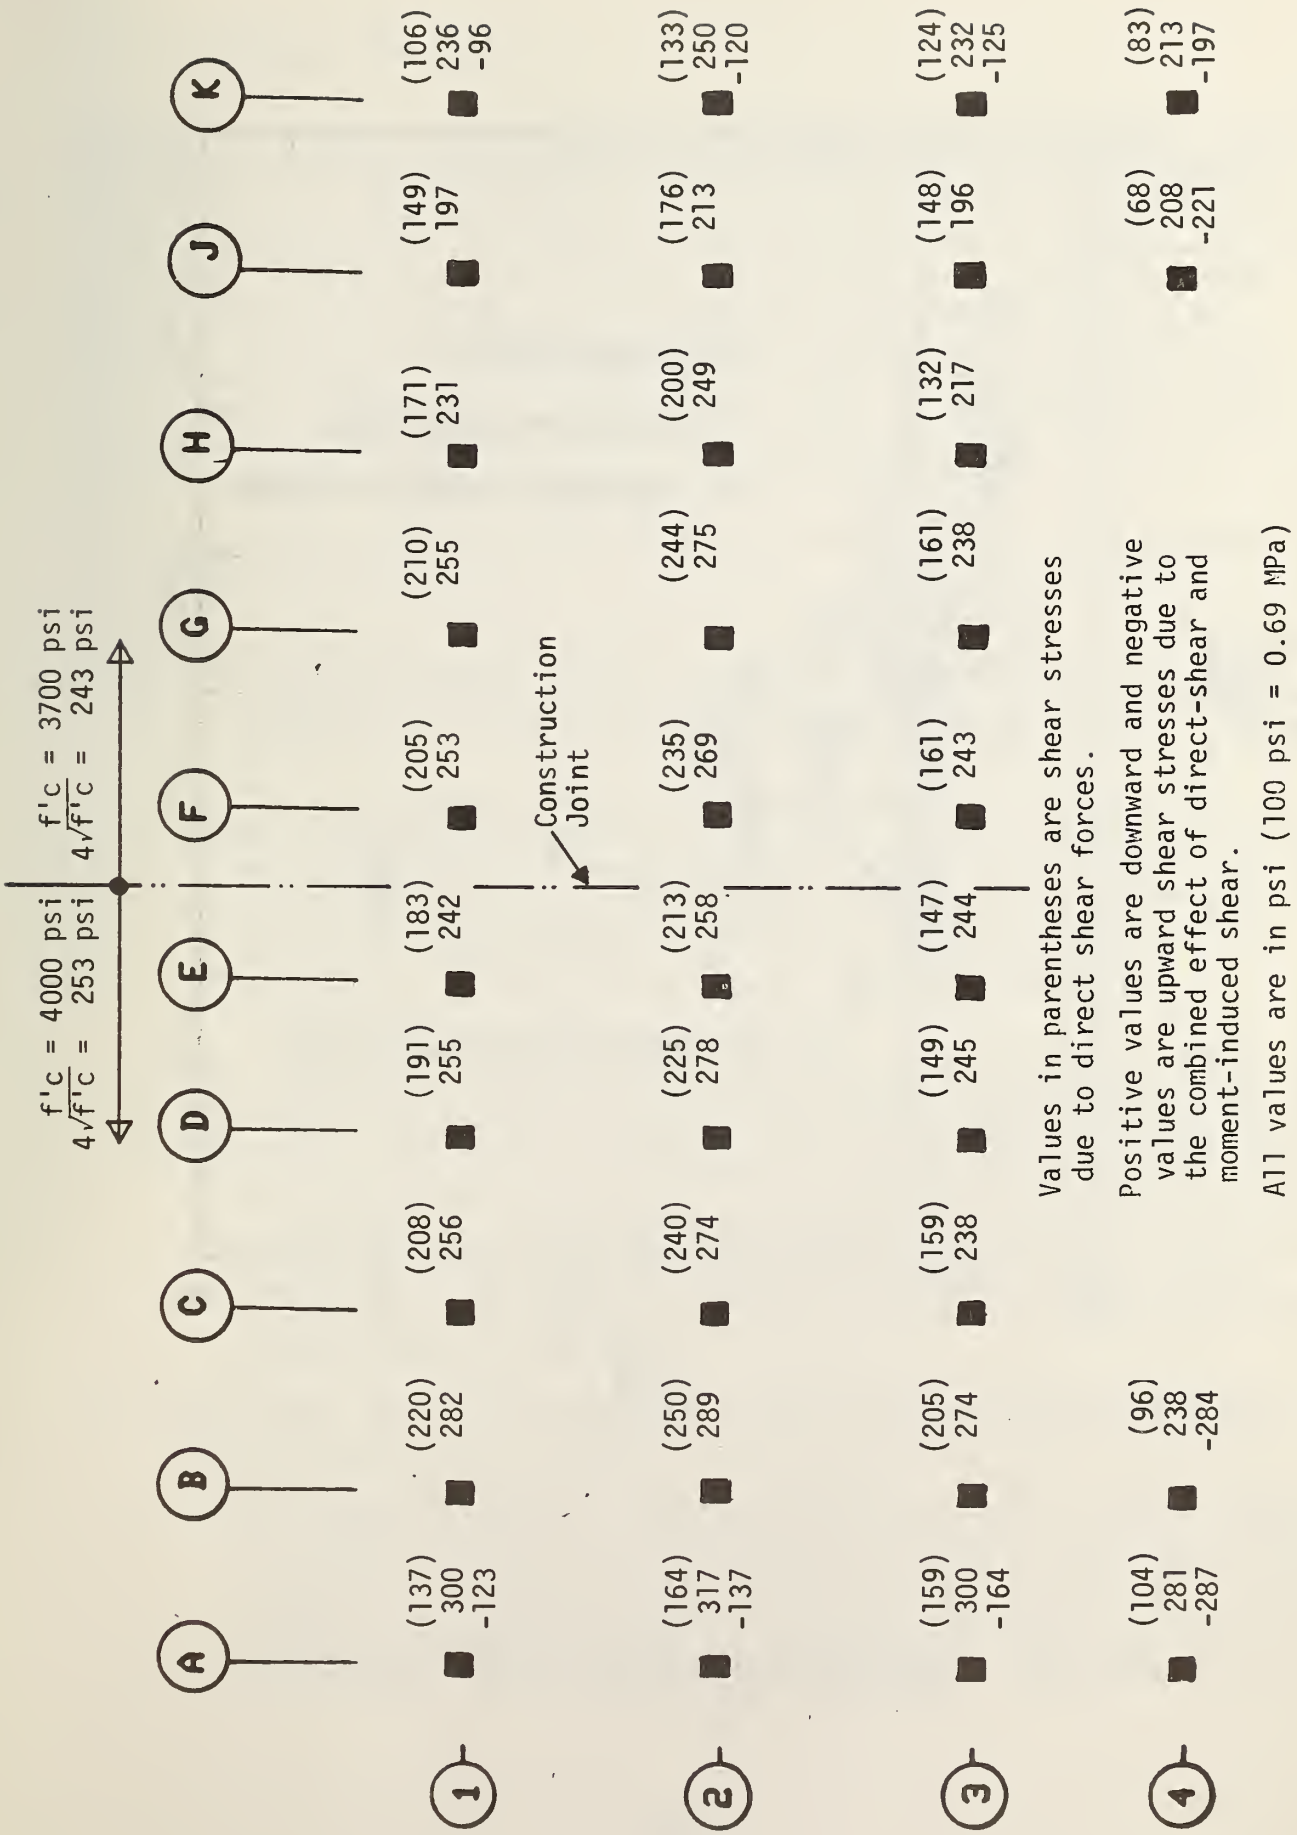
Figure 6.4 Punching shear stresses in fifth floor slab

than the shear strength of the fourth floor slab. The third and second floor slabs failed by the same process. Thus, collapse of the entire structure was initiated by punching shear failure of the slab at the fifth floor level.

It is concluded that the most probable cause of the failure was the lack of adequate punching shear capacity in the fifth-floor slab at several of the columns to resist the applied construction loads. This deficiency was brought about by the design inadequacy which resulted in the slab thickness of 8 in instead of 11-in and by the placement of the top reinforcement at the column strips with significantly greater cover than that which would have met the cover requirement specified by the structural drawings. This resulted in an insufficient effective depth of the fifth floor slab to resist punching shear under construction loads.
